# Memorandum

## Alleghany Tank Inspection

December 22, 2022

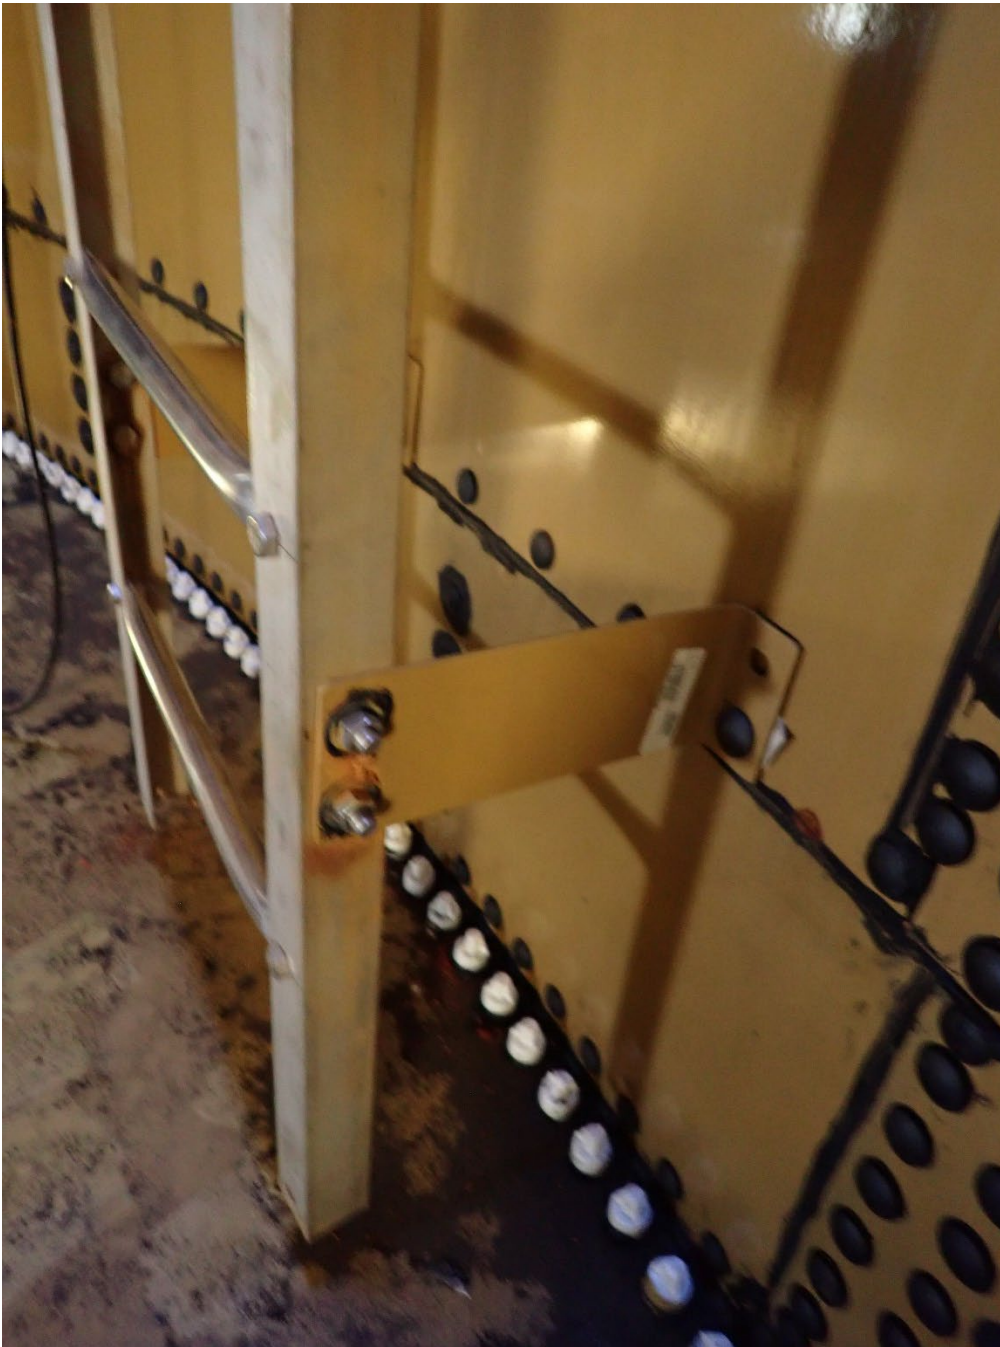
circuit to form in the water that destroys the weaker metal where exposed. The aluminum, interior ladder not being isolated from the carbon steel tank shell caused the most severe corrosion and the floor leak. Similar pitting corrosion in the floor panels is occurring where the stainless steel cables that tether the level gauge float connect to the floor. From the inspection report:

Aluminum ladder with rust at connections and at seam on wall

- Replace panels with significant corrosion or pitting.
- Repair interior coating at roof beam / shell interface.
- Repair defects in interior coating at all lower locations including bolts, manway, ladder, float, pipe inlet, and all holidays.
- Replace subgrade where washed out under tank bottom panels.
- Install dielectric isolation on the float support structure (and ladder connections if keeping the aluminum ladder).
- Repair sealant as necessary, based on subsequent analysis.

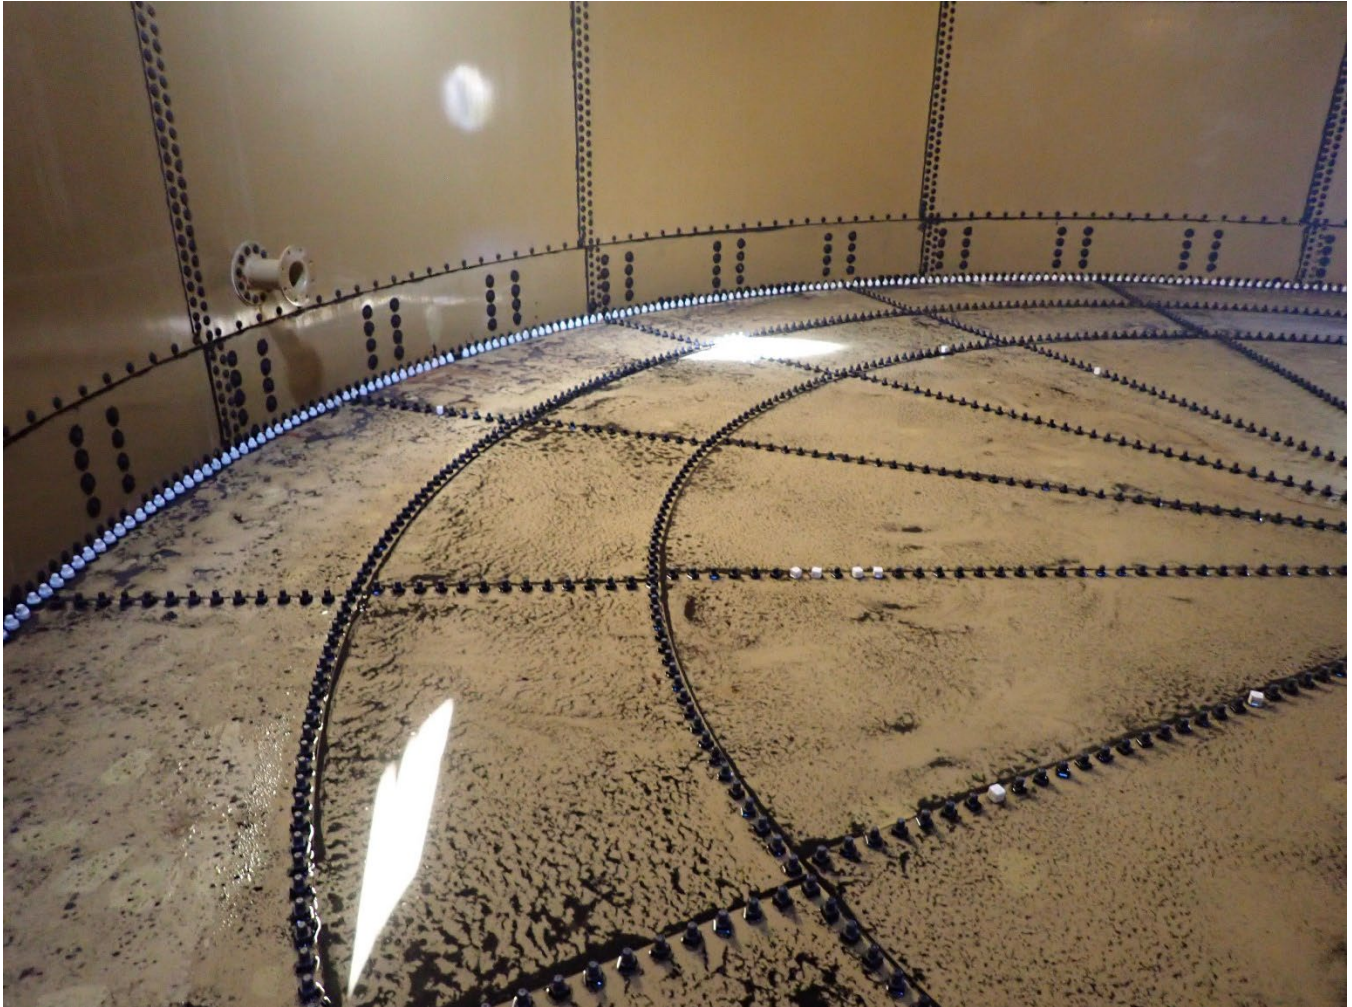
The inside tank bottom had substantial quantities of black sediment particles in the puddles of remaining water. The sealant at the tank seams appears to be the source of the black sediment on the bottom. The sealant throughout the tank interior is crumbly and easily disintegrates into similar black powder when touched. The sealant on the tank outside was hard and intact and not crumbly like the same substance on the inside. It is not known whether this sealant was intended to harden or remain more flexible.

Tank floor with black sediment

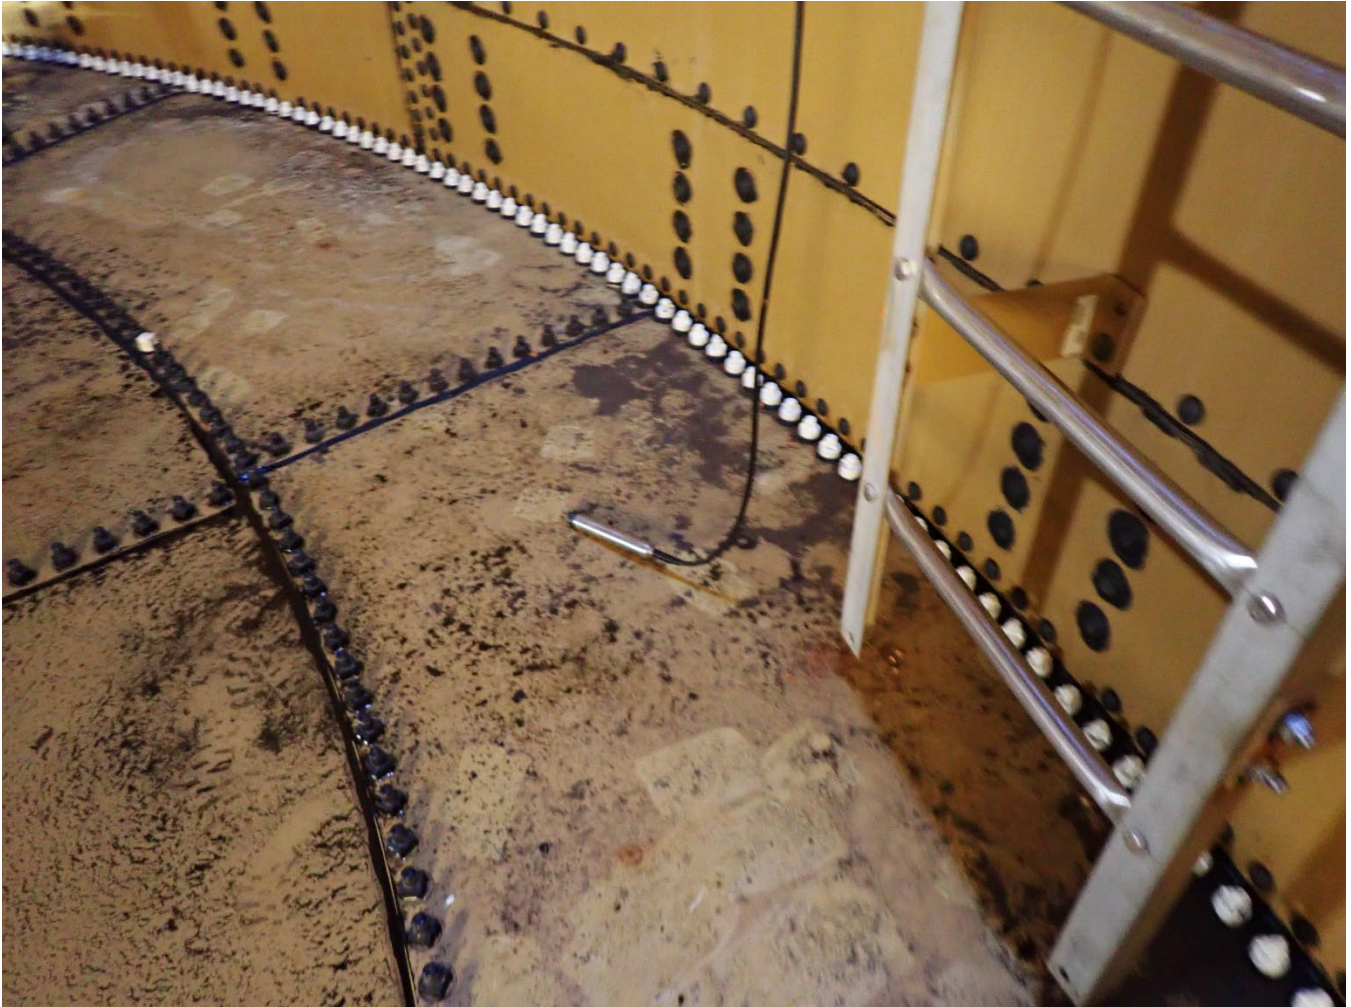
Inside the tank there were notable signs of corrosion mostly at the bolts and appurtenances. Also noted were several areas of pitting located in the steel bottom panels near the aluminum internal ladder. Some pits still had paint (coating) bridging over them with only a small hole in the coating. The holes in the steel underneath were approximately the size of a nickel and a few penetrated through the bottom plates. Additional pitting was noted on the floor panels at the location of the level gauge float attachment cables. In at least one location the subgrade below leaking area(s) has apparently washed away leaving void spaces below the tank bottom. The floor flexes up and down several inches with changes in loading. Throughout the lower portions of the tank there are numerous bolts that are exhibiting corrosion. There was additional corrosion at the tank inlet and outlet pipes and notable coating defects at the manway. The coating at the manway had previously been repaired but was chipping and peeling with rust forming on the bare metal. The corrosion on the bolts was widely dispersed and most prevalent near the ladder and in the level gauge float attachment area. There was also corrosion of significance at the connection between the shell and the cross beam that supports the roof. Photos of onsite observations are attached.

Transducer on floor, rust pits dispersed around and at foot of the ladder

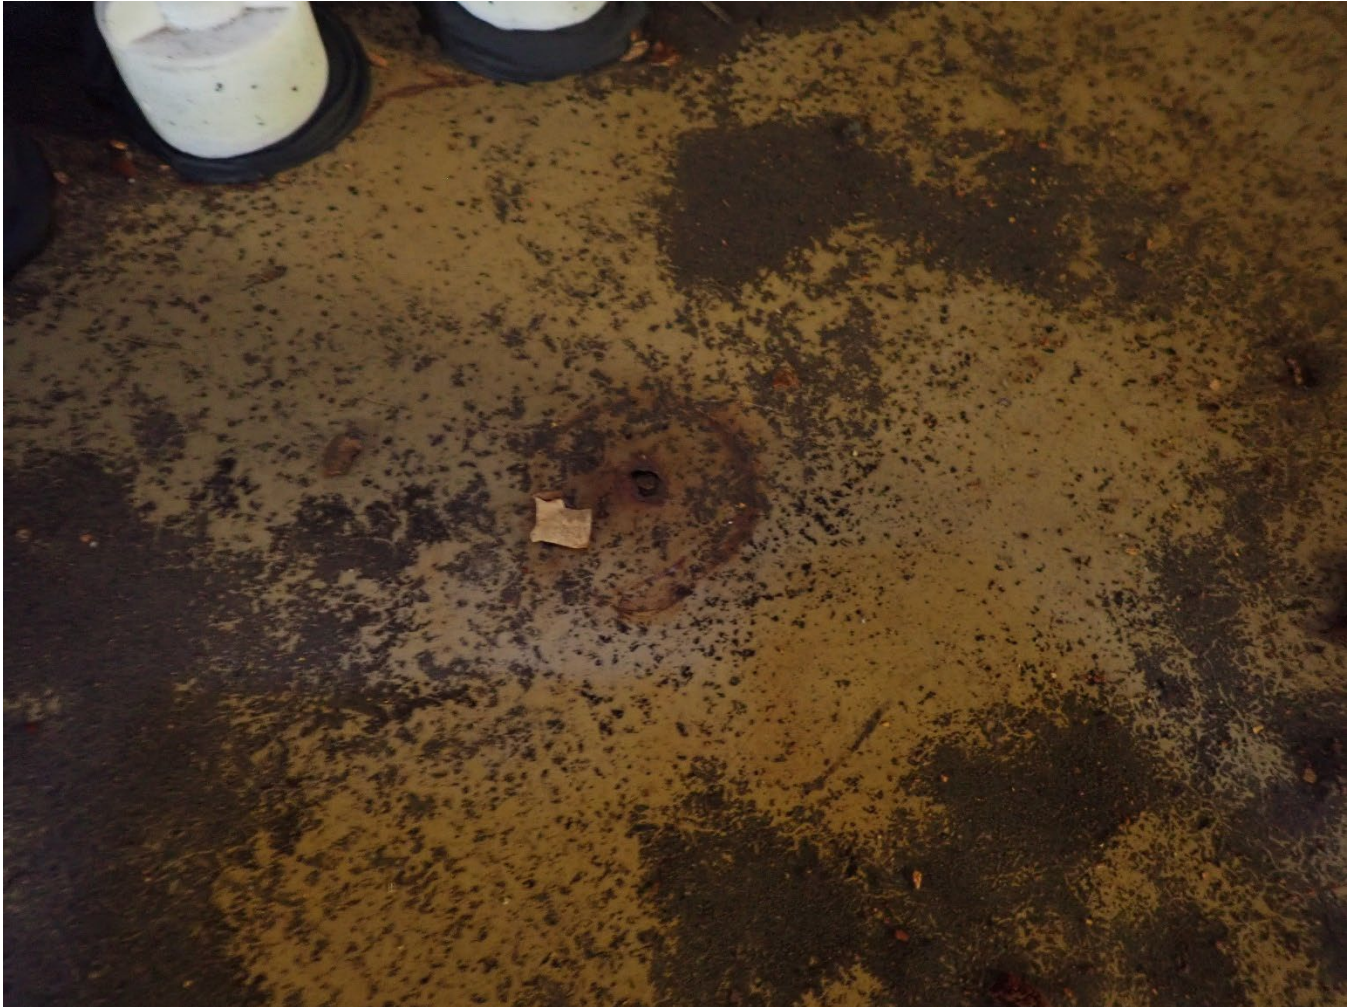
Close up of a rust pit on floor

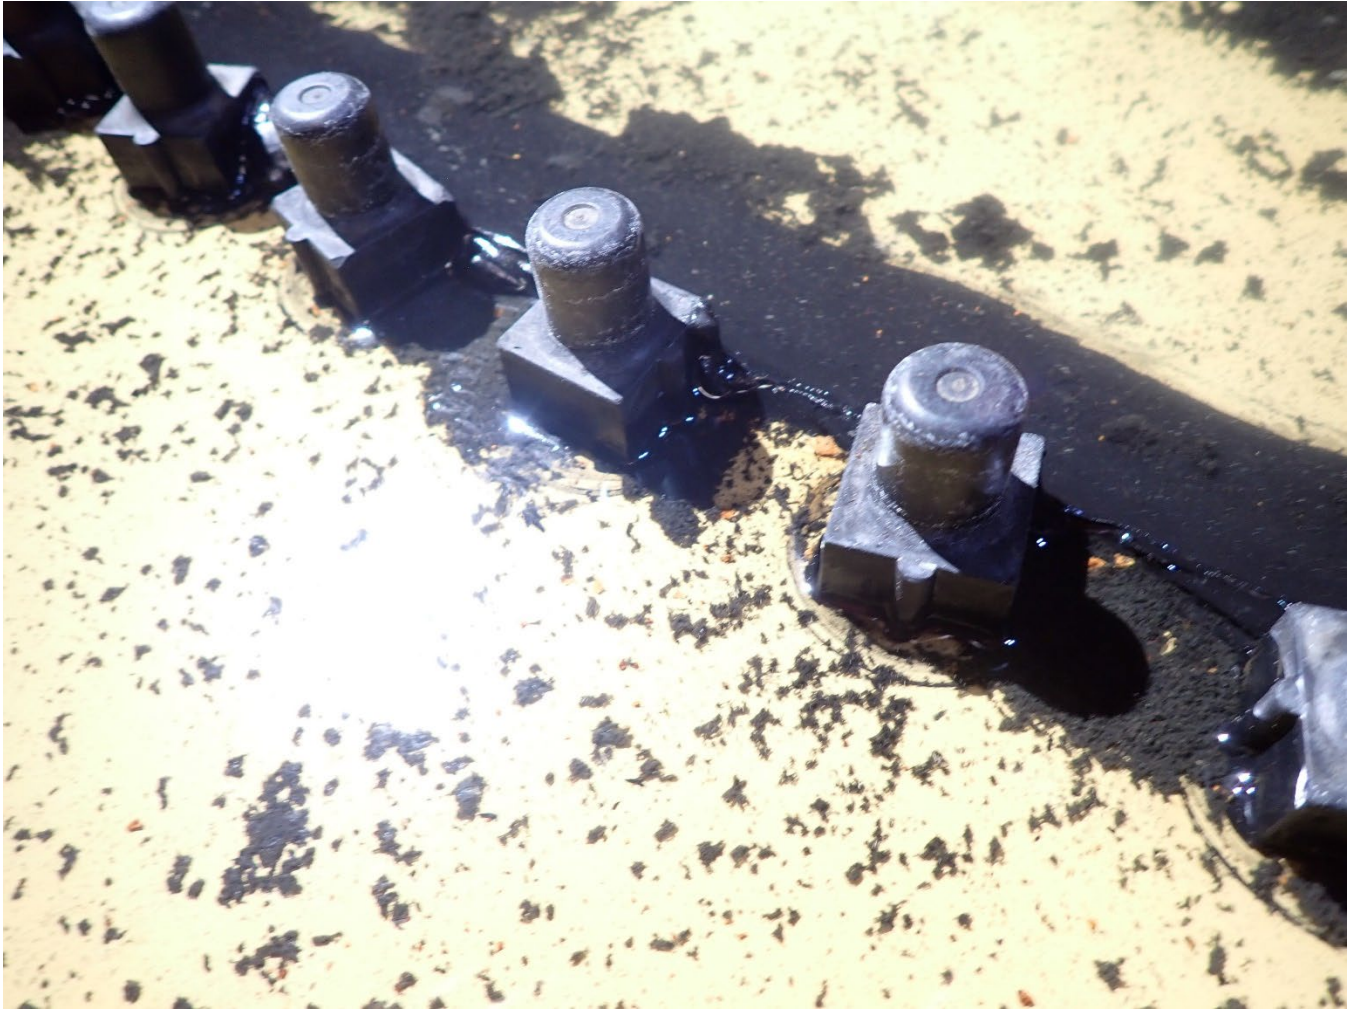
Close up of black sediment

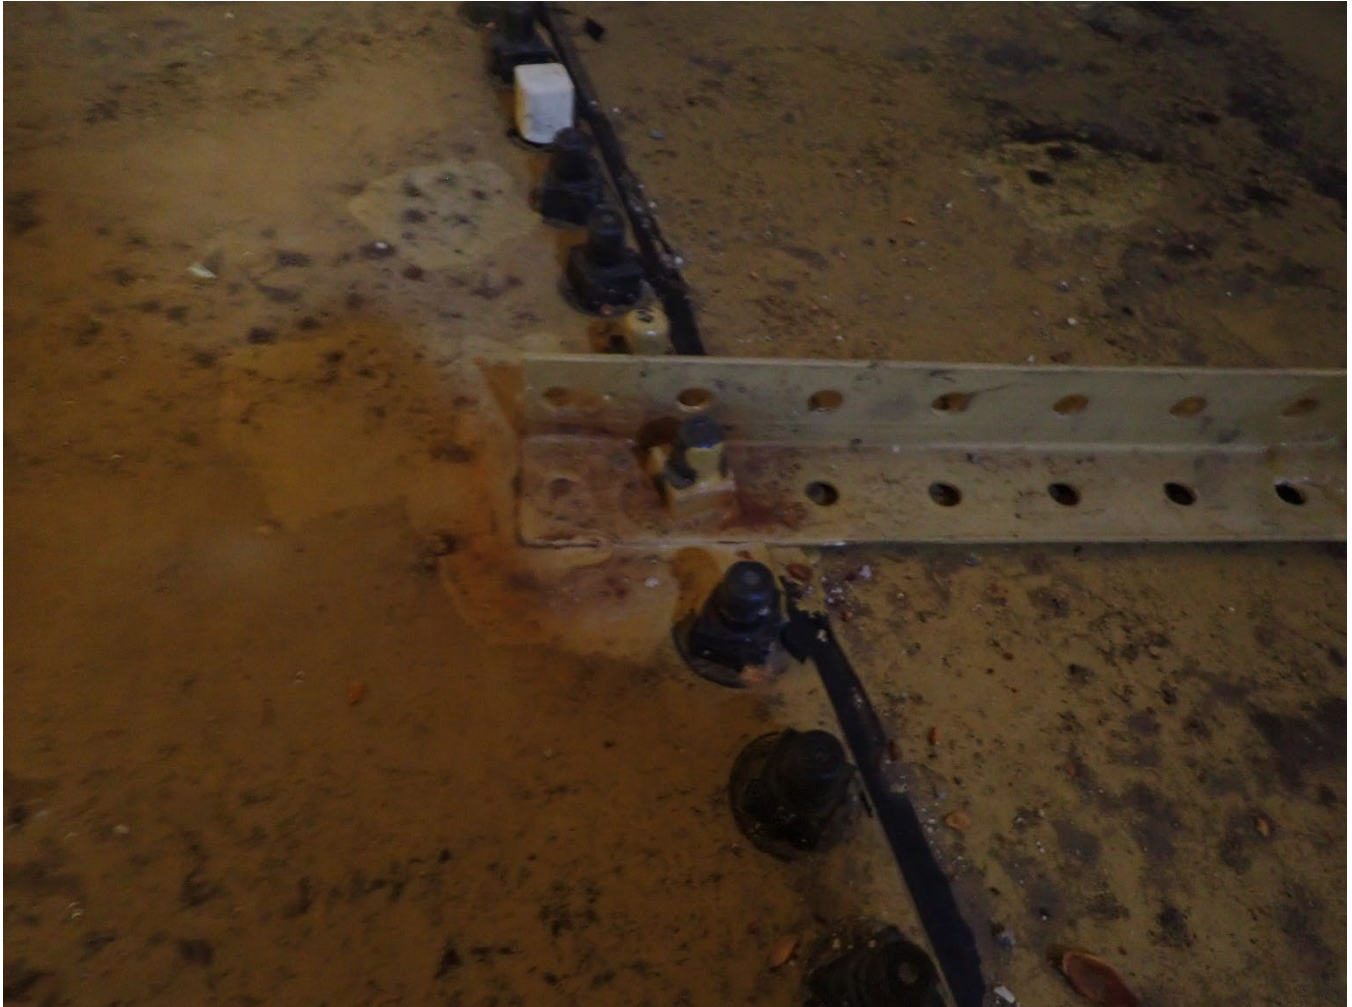
Corrosion at connection of level gauge float support structure

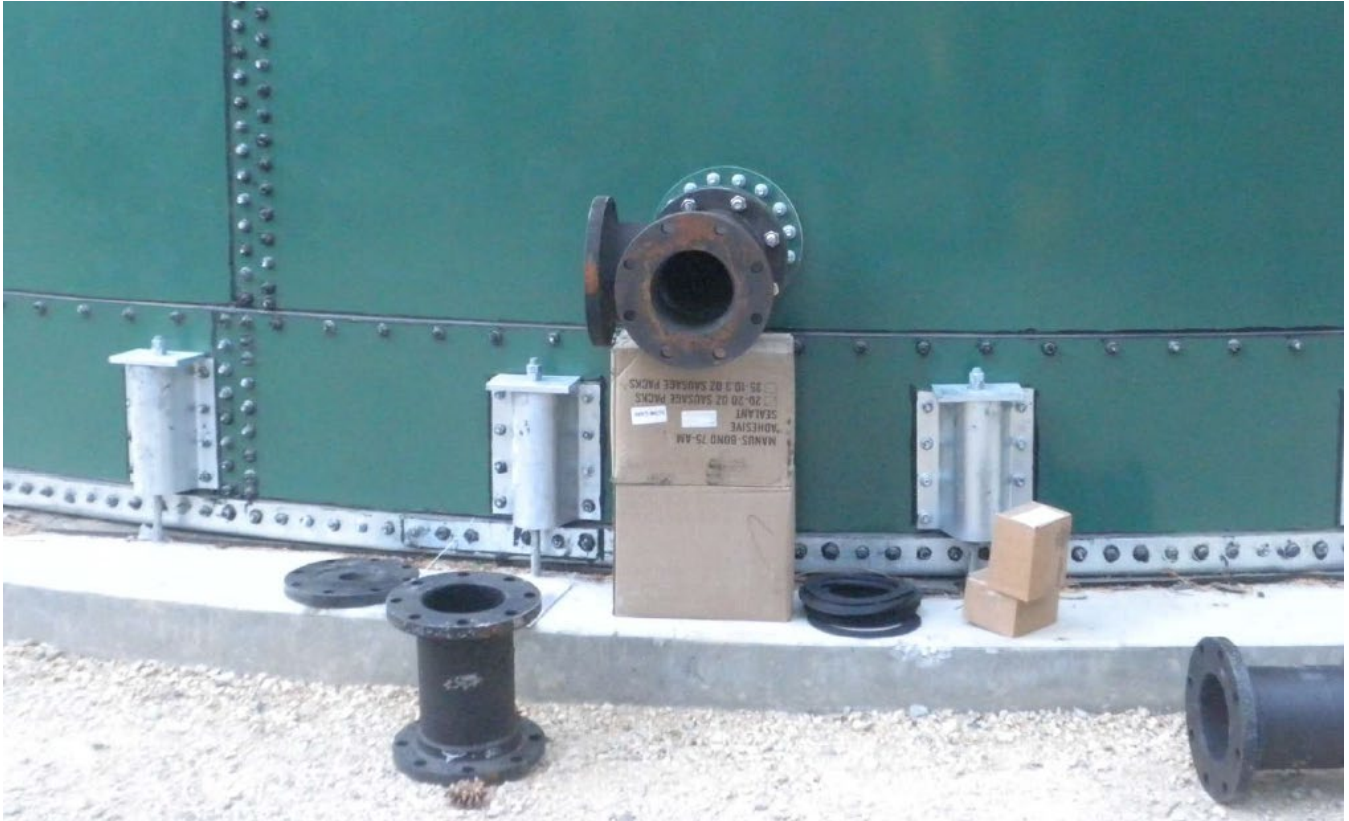
The sealant failure adds a new line of inquiry that must be resolved to ensure the tank functions as intended. Based on a photo taken during construction (attached below), the sealant used is Manus Bond 75 AM. The labeling on the box in the photo appears to be the ‘USDA accepted’ product type, not the NSF 61 certified type as required by CA regulations. Better documentation of the sealant used during construction was not available. The manufacturer’s data sheets for the sealant are attached.

Photo provided by ACWD of sealant box during construction.

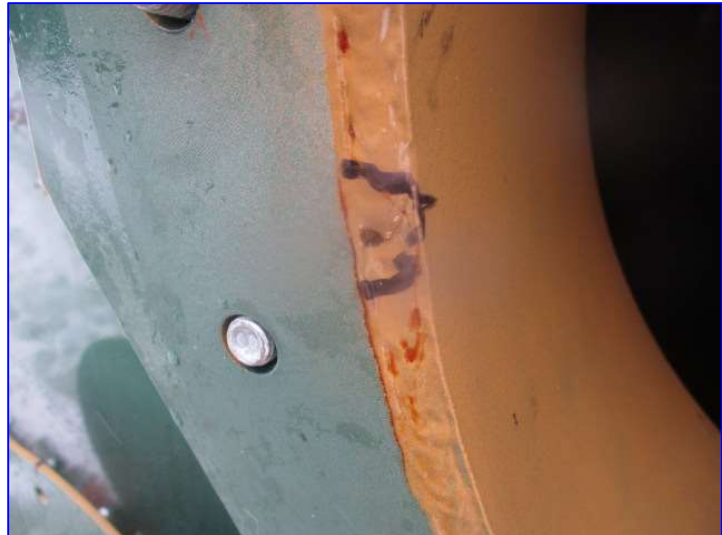
Photo 11 – Interior (Jan 2020) – Shell manway exhibits spot rust at flange mating surfaces.

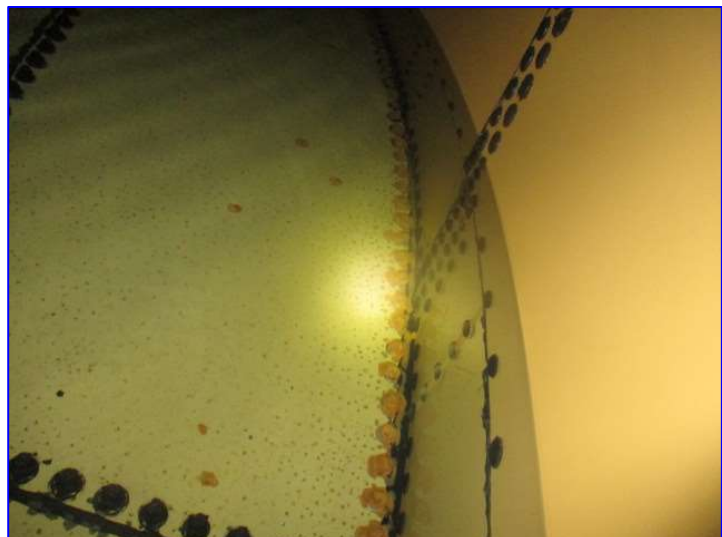
Photo 15 – Interior (Jan 2020) - View of  
the tank chime where rust nodules  
have developed around galvanized  
bolts.

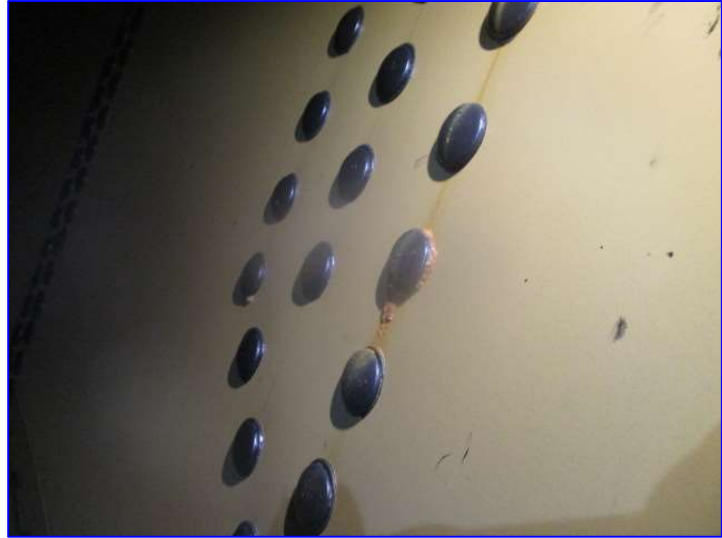
Photo 16 – Interior (Jan 2020) – View of isolated shell bolts where rust has developed.

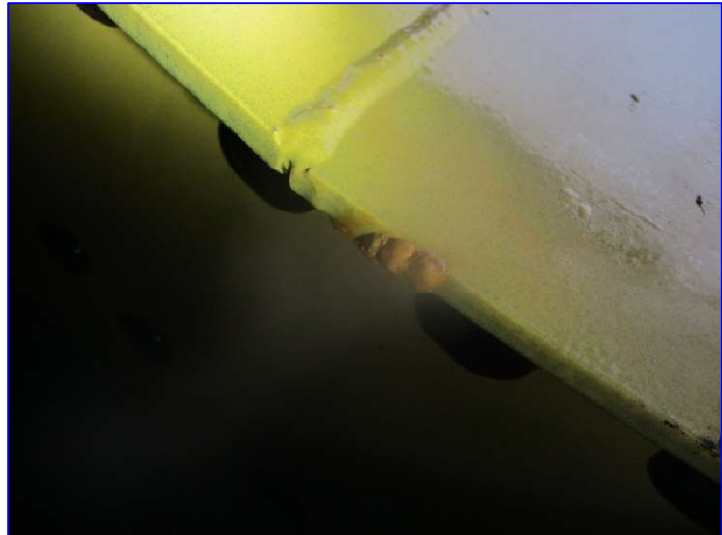
Photo 17 – Interior (Jan 2020) – View of rust nodules at the shell manway.

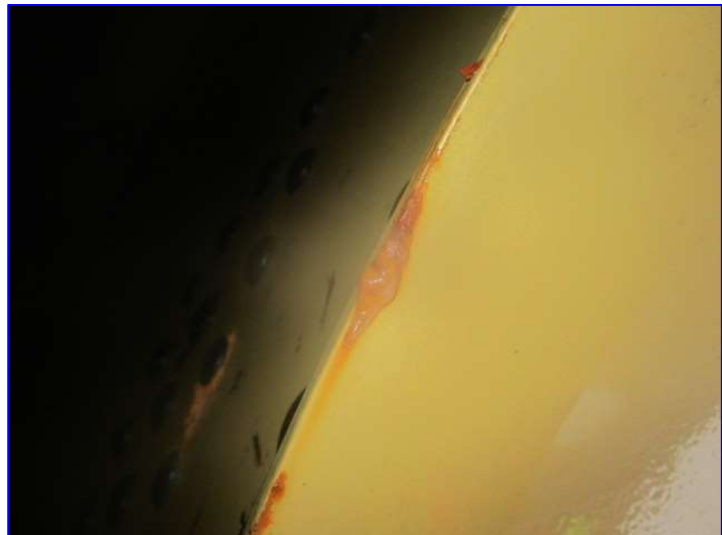
Photo 18 – Interior (Jan 2020) – View of spot rusting at the edges of the shell manway.

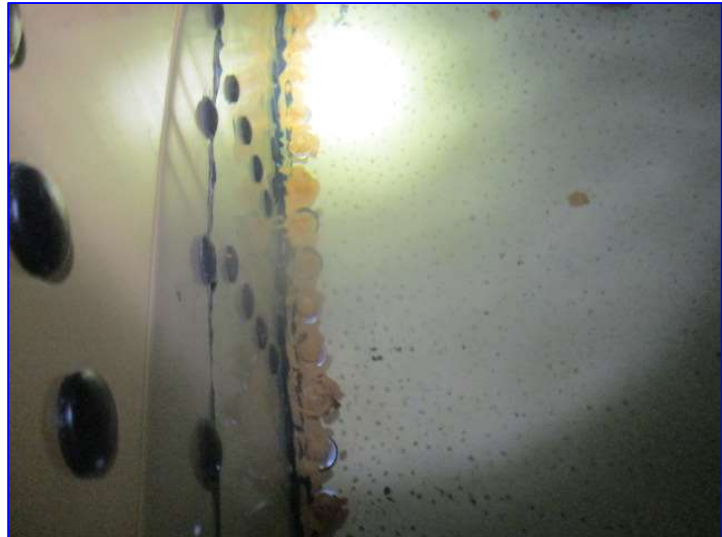
CSI also noted that rapid galvanic corrosion is occurring on some bolted connections because the bolts are dissimilar metal to the shell materials being joined. In these cases, the coating was likely damaged during assembly.

**Photo 19 – Interior (Jan 2020) – View of the tank chime where bolts connecting the floor plate to the shell starter ring have developed rust nodules due to the galvanic corrosion between the bolt and the chipped coating at the bolt hole.**

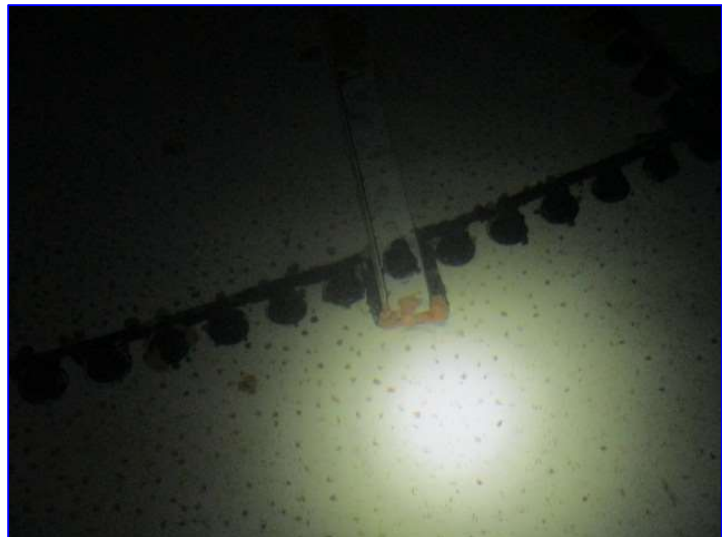
**Photo 20 – Interior (Jan 2020) – View of rust forming at the edge of the bolt channel.**

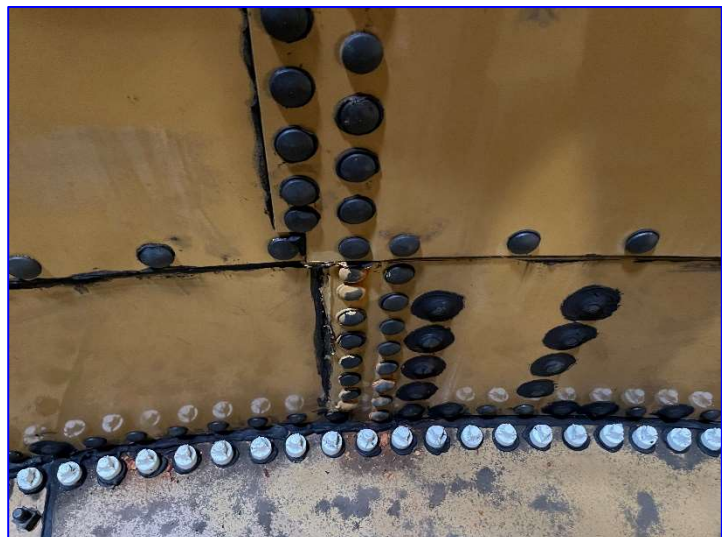
Photo 24 – Interior (June 2022) – View  
of rust forming at the edges of some  
capped bolts.

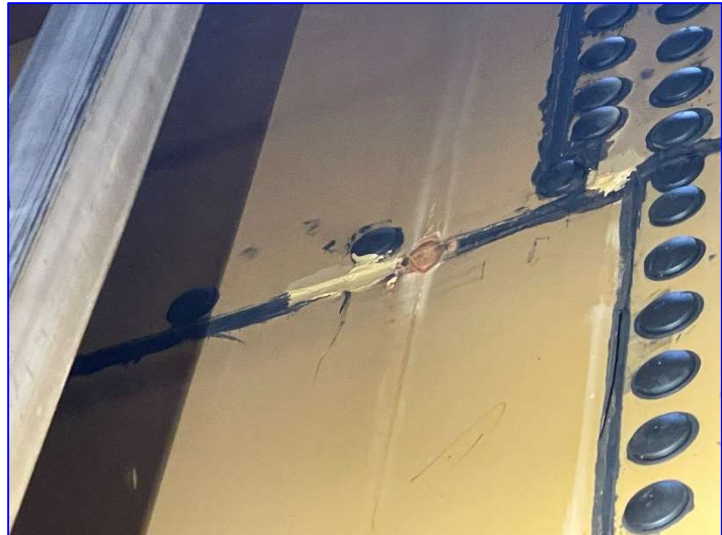
Photo 26 – Interior (June 2022) – View  
of a caulked plate seam where rust has  
formed.

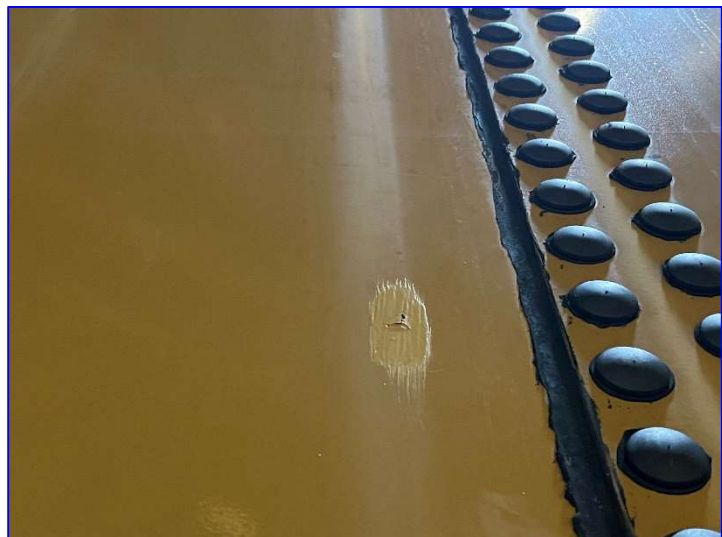
Photo 27 – Interior (June 2022) – View  
of a lining repair that appears to have  
failed.

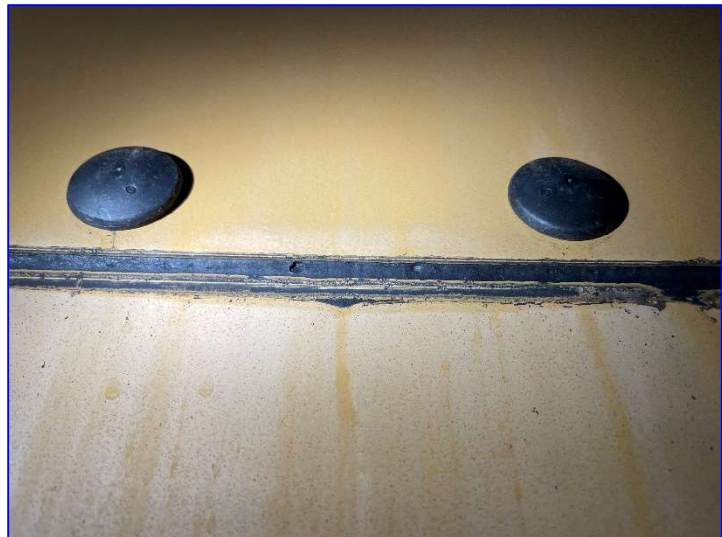
Photo 29 – Interior (June 2022) – View of minor staining at the edge of a shell plate lap.

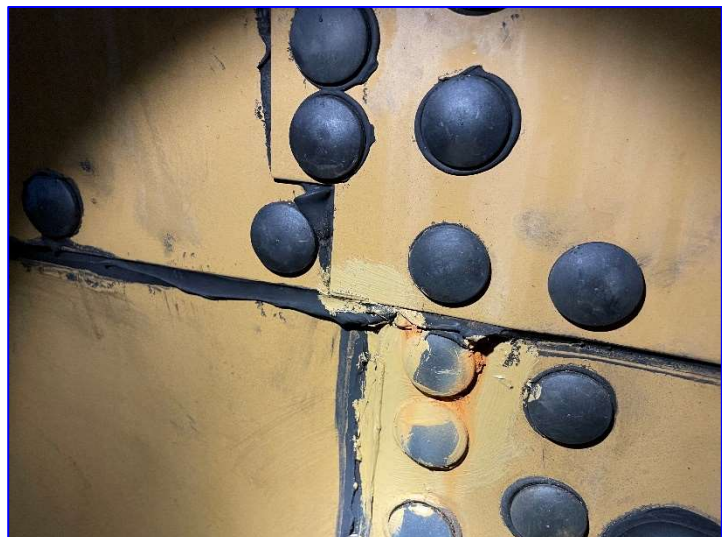
Photo 30 – Interior (June 2022) – View of rust forming at the edges of some capped bolts.

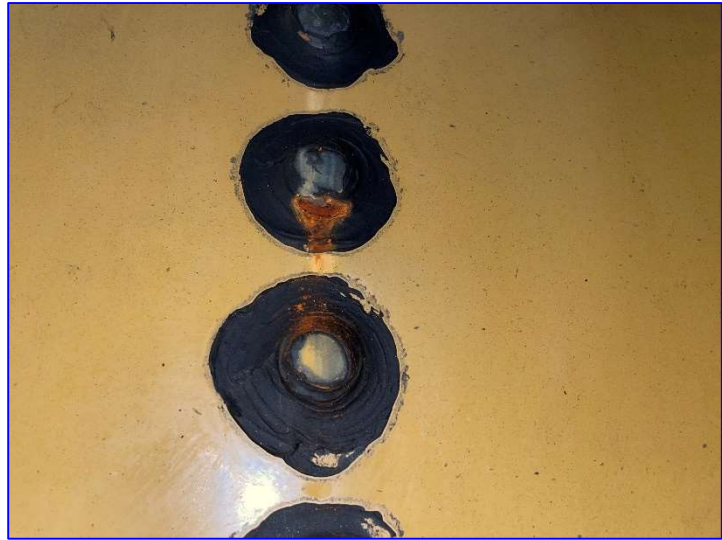
Photo 31 – Interior (June 2022) – View of rust forming at the edges of some capped bolts.

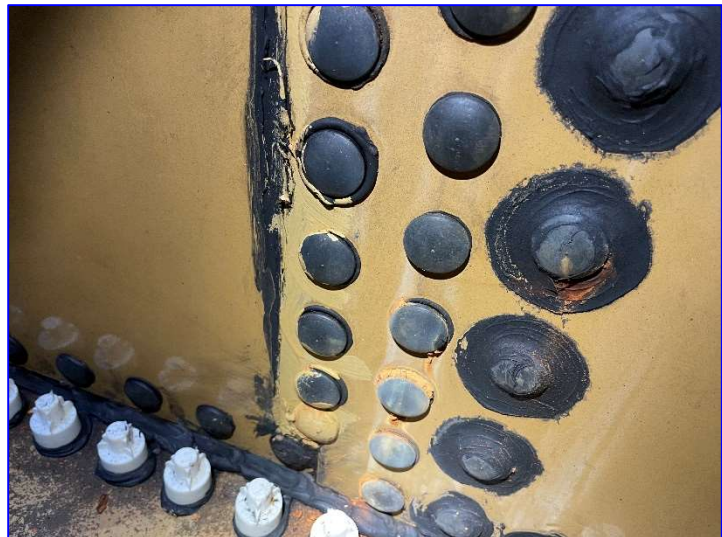
Photo 32 – Interior (June 2022) – View of rust forming at the edges of some capped bolts.

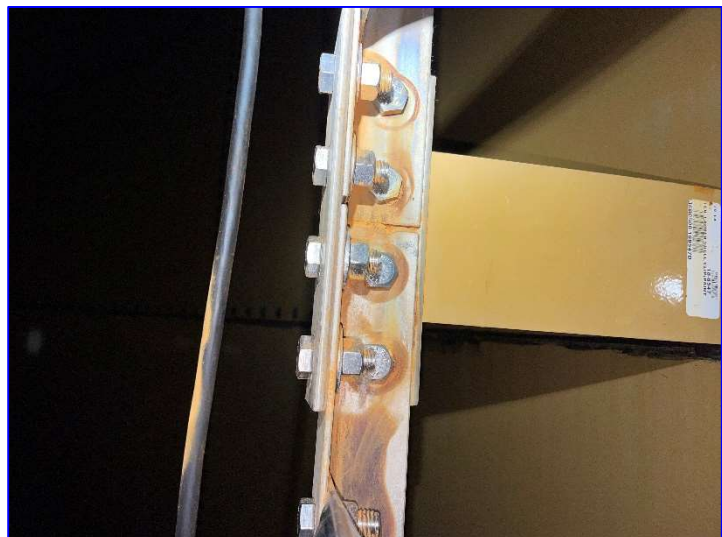
Photo 33– Interior (June 2022) – View of the ladder where stainless steel fasteners mate aluminum to carbon steel and the resulting galvanic corrosion.

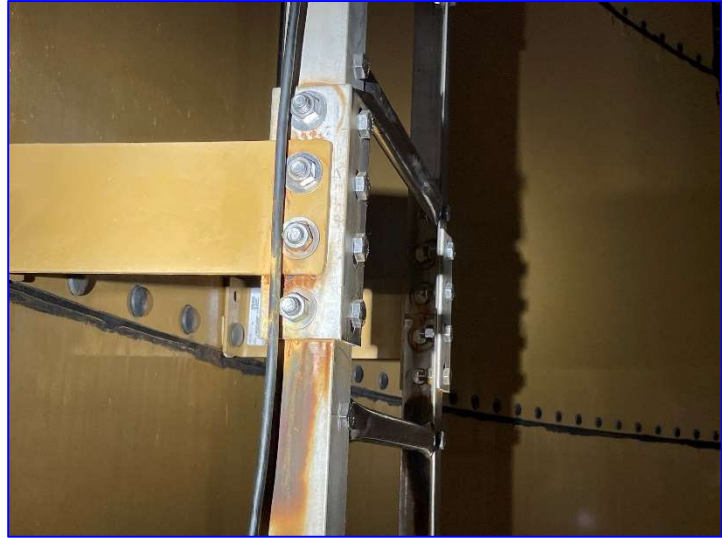
**Photo 34 – Interior (June 2022) – View of the ladder where stainless steel fasteners mate aluminum to carbon steel and the resulting galvanic corrosion.**

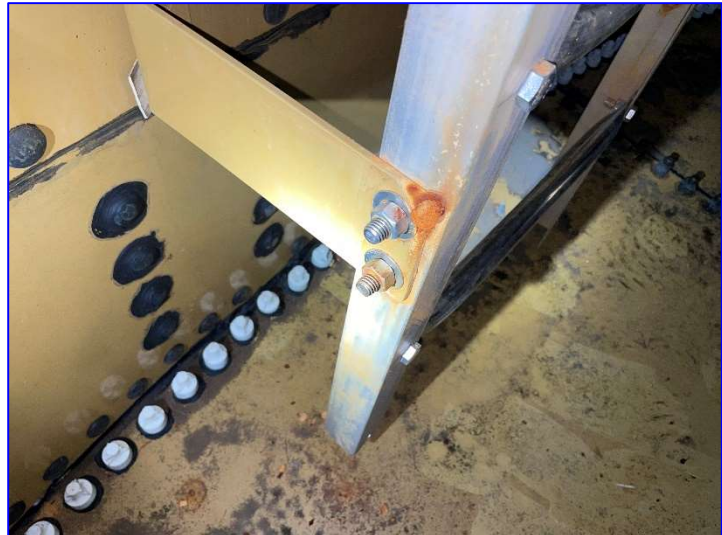
**Photo 35 – Interior (June 2022) – View of rust forming at the edges of the ladder stand-offs.**

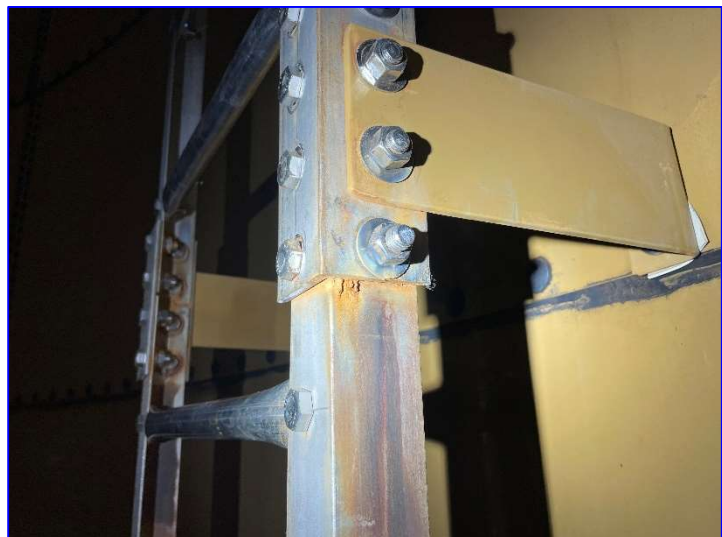
**Photo 36 – Interior (June 2022) – View of rust weeping from faying surfaces at the ladder.**

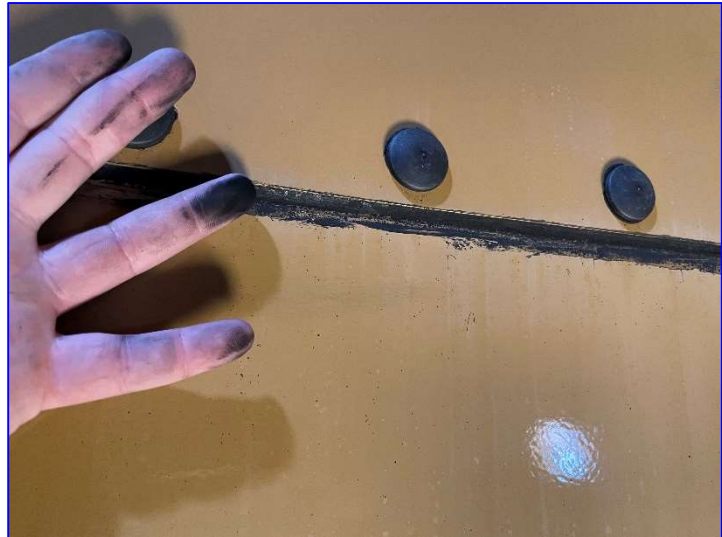
Photo 37 – Interior (June 2022) – View of residue wiped from the surfaces of the sealant.

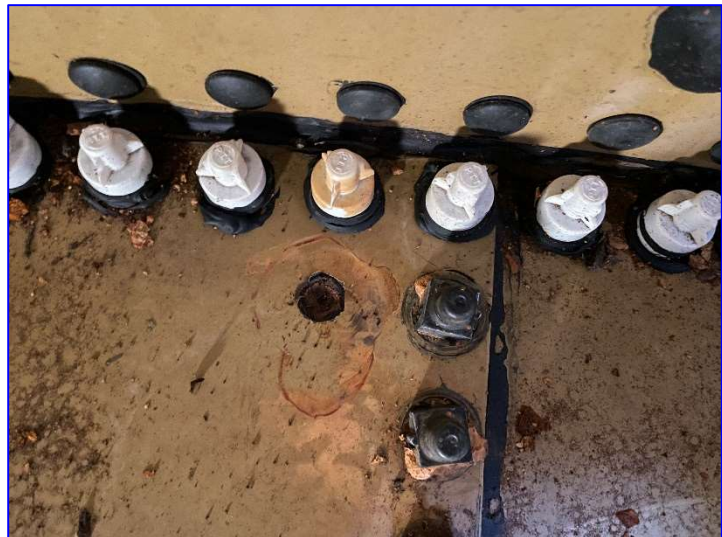
Photo 38 – Interior (June 2022) – View of a through penetration of the tank bottom.

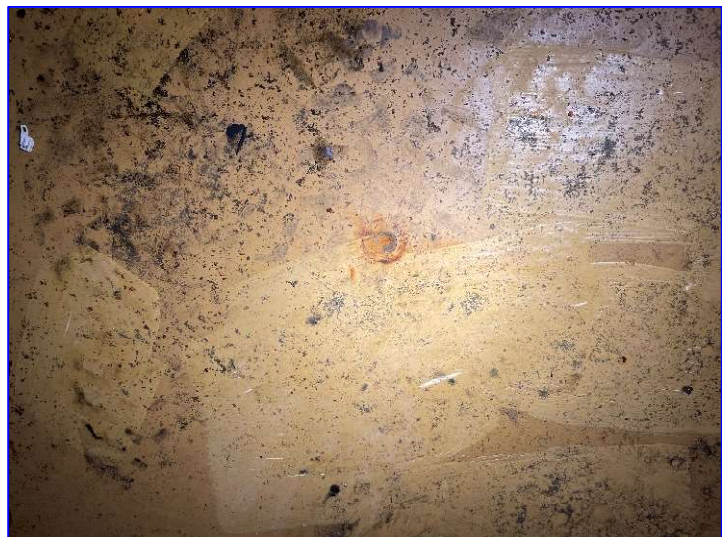
Photo 39 – Interior (June 2022) – View of a site at the tank bottom where a rust nodule has been removed leaving behind deep pitting in the carbon steel.

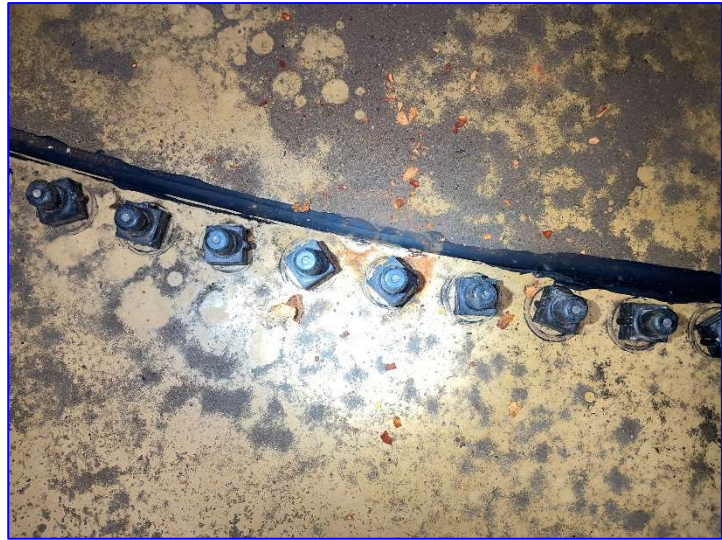
Photo 40– Interior (June 2022) – View of areas of spot rust at the tank bottom, likely caused by mechanical damage.

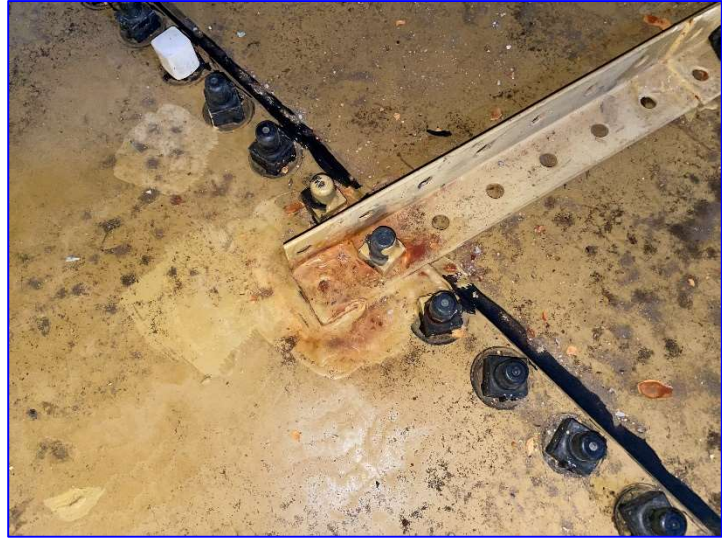
Photo 43 – Interior (June 2022) – View of rust forming at bolt holes of a tank accessory.

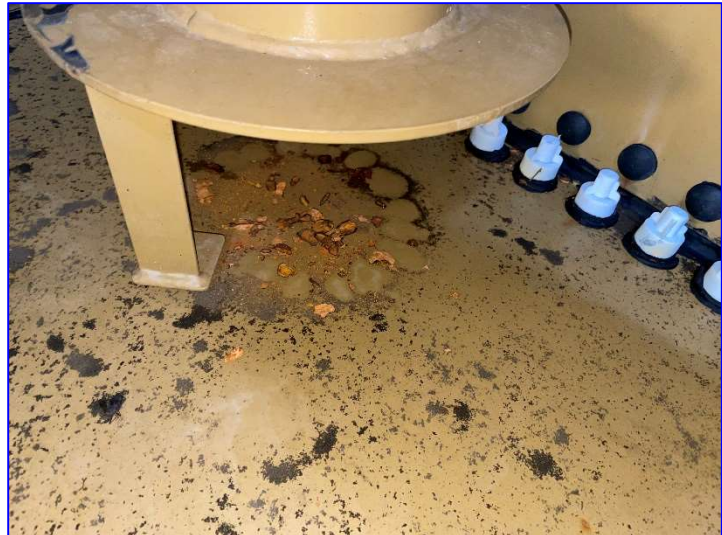
Photo 44 – Interior (June 2022) – View of rust staining from metallic debris.

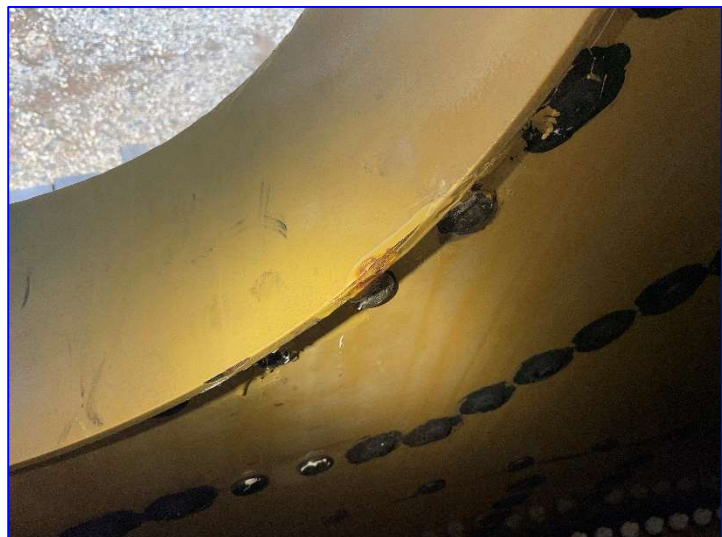
Photo 45 – Interior (June 2022) – View of rust forming at sharp edges of the manway.

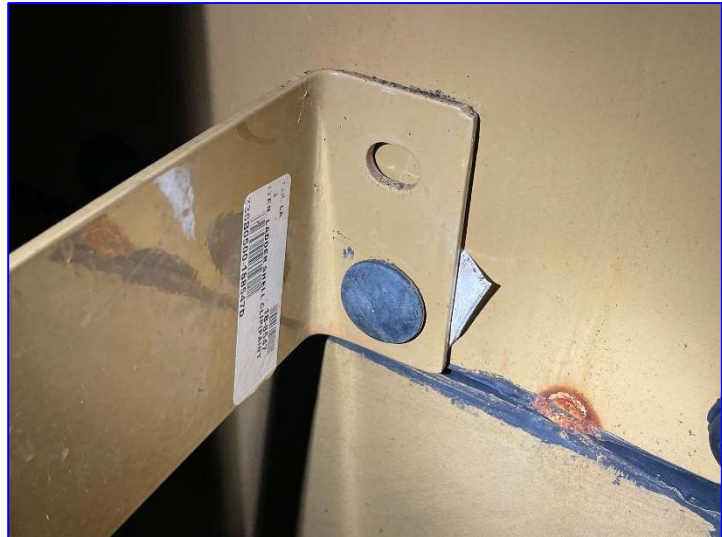
Photo 46 – Interior (June 2022) – View of rust forming at an area of incomplete sealant application

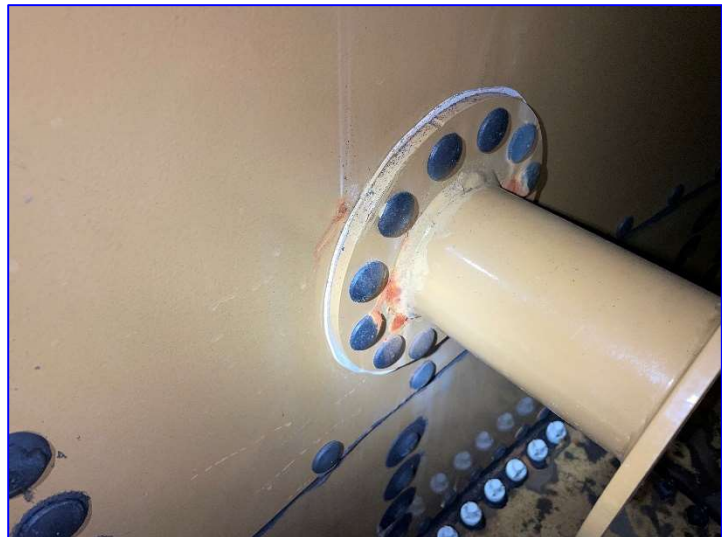
Photo 47 – Interior (June 2022) – View of rust forming at the edges of some capped bolts, accessory flange and piping.

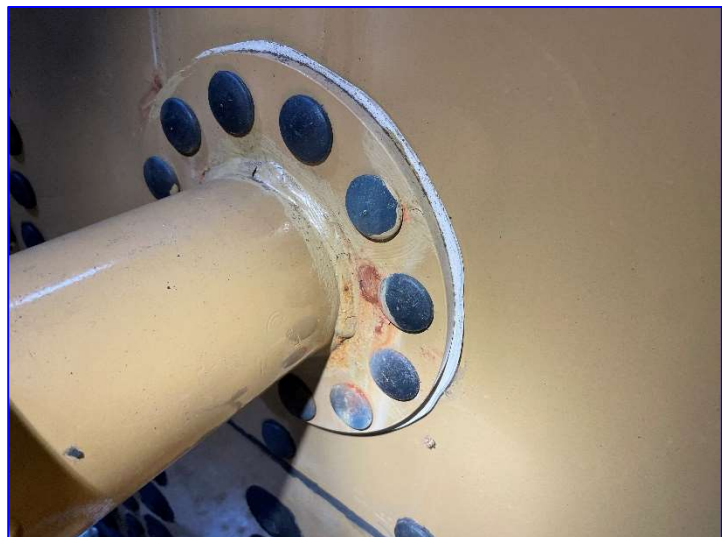
Photo 48 – Interior (June 2022) – View of rust forming at the edges of some capped bolts.
