# Memorandum

## Alleghany Tank Inspection

December 22, 2022

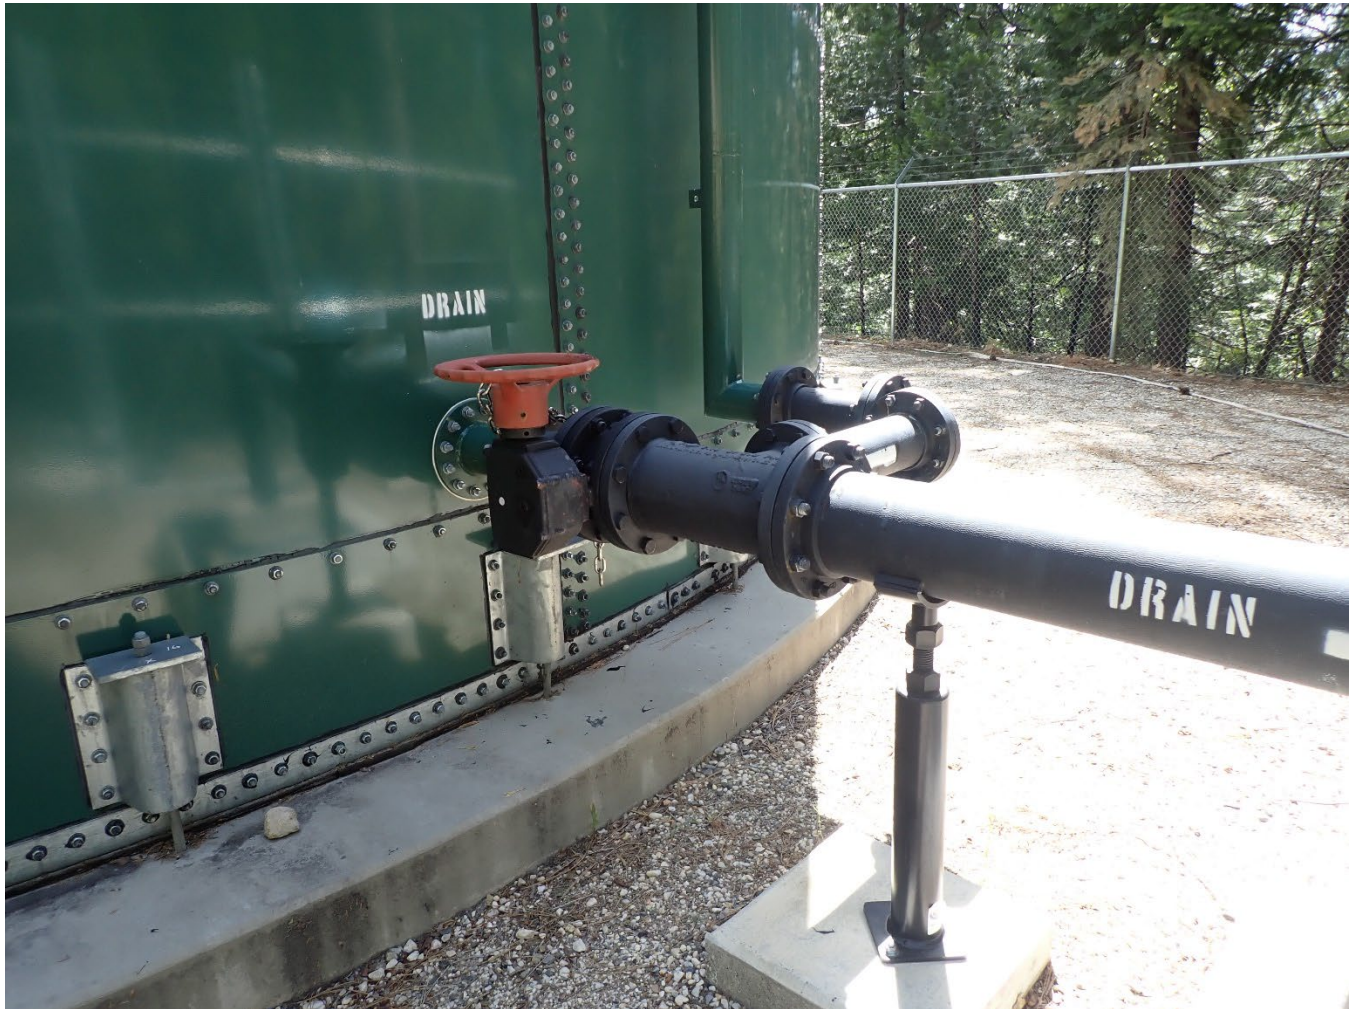
Exterior of the tank

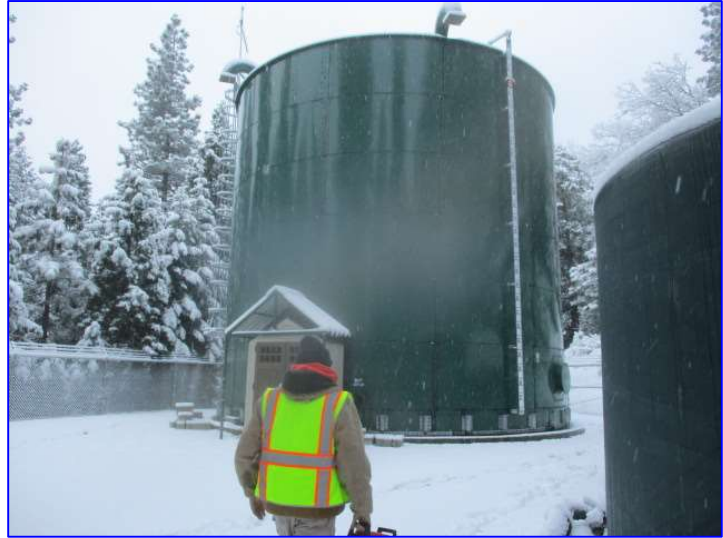
**Photo 1 – Exterior (Jan 2020) –  
Overview of the Allegheny Bolted Tank**

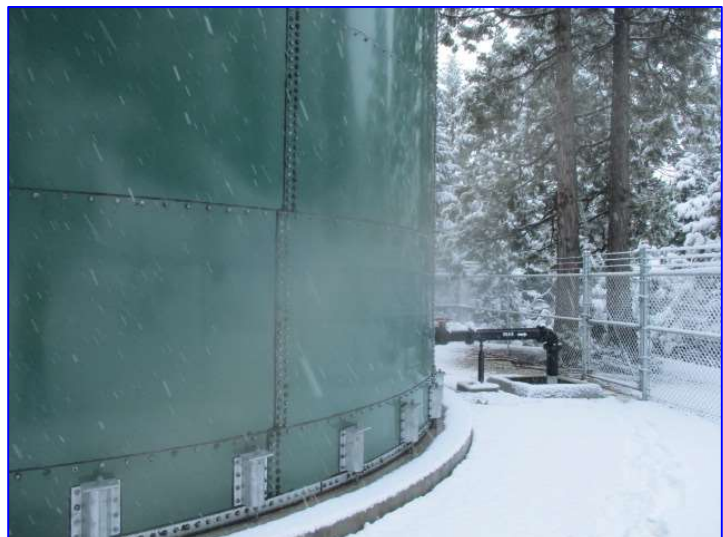
**Photo 3 – Exterior (Jan 2020) – View of  
the lower shell courses and anchorage  
to the concrete foundation.**

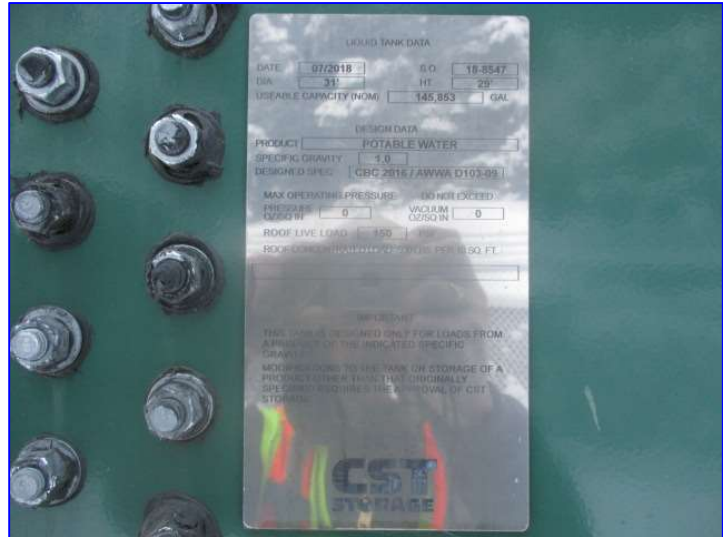
Photo 4 – Exterior (Jan 2020) – Tank manufacturer’s nameplate.

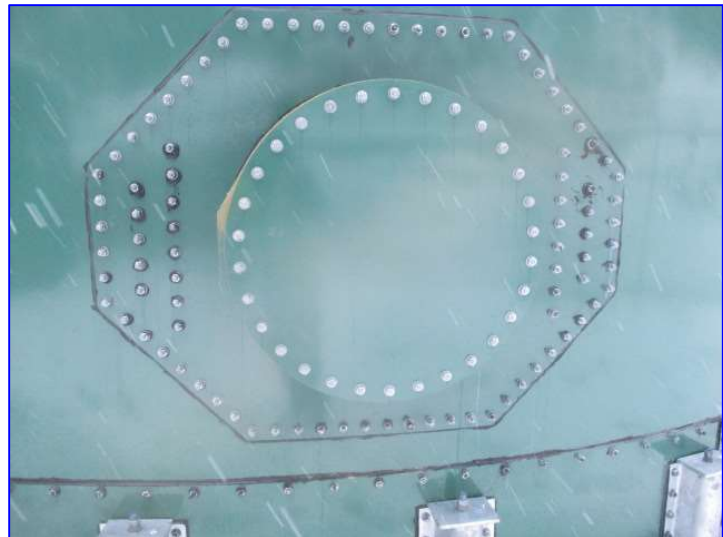
Photo 5 – Exterior (Jan 2020) – View of the tank shell manway (1 of 2)

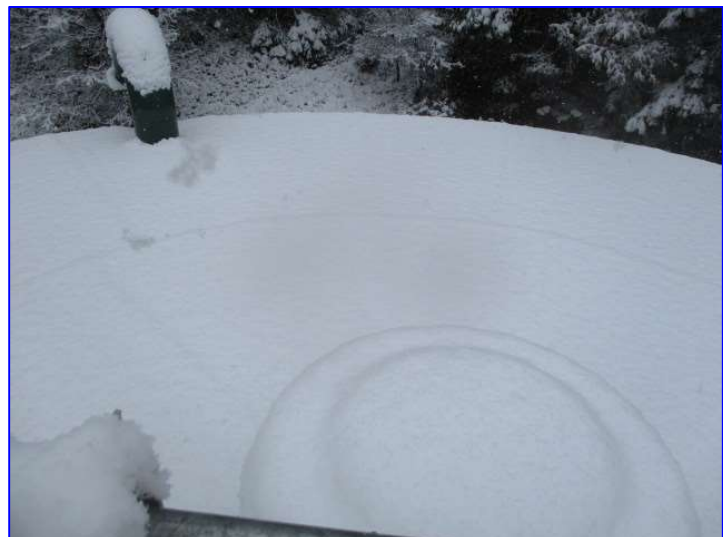
Photo 6 – Exterior (Jan 2020) – Roof surfaces were covered with snow at the time of the inspection.

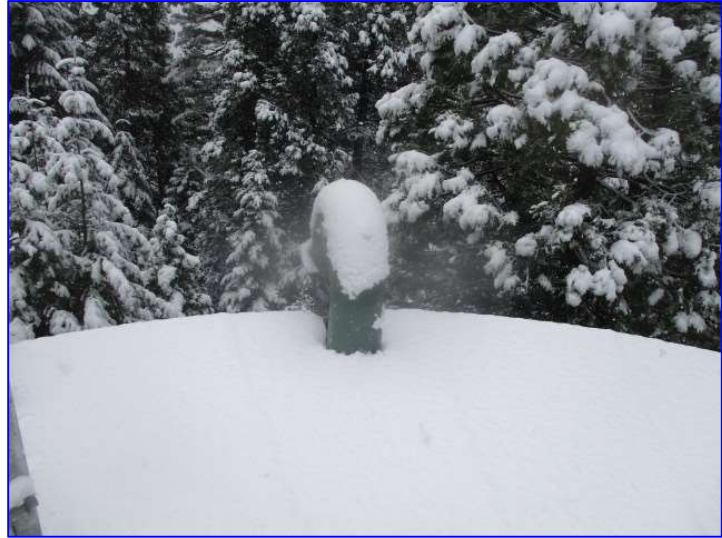
Photo 7 – Exterior (Jan 2020) – View of perimeter roof vent.

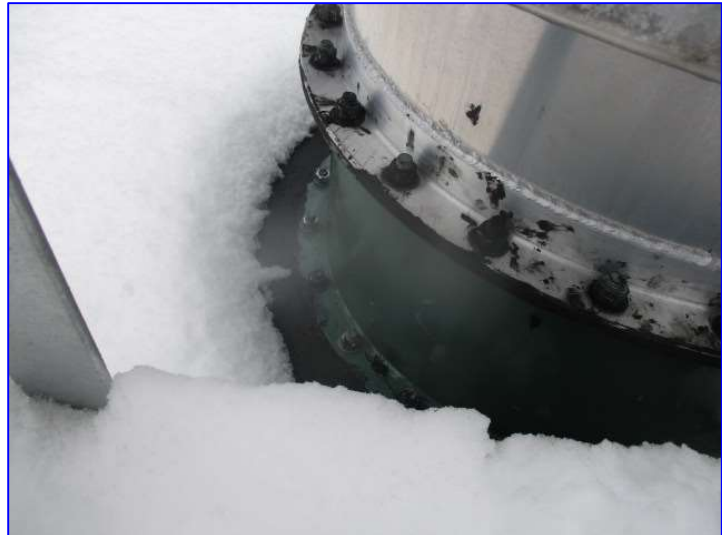
Photo 8 – Exterior (Jan 2020) – View of the aluminum center vent.

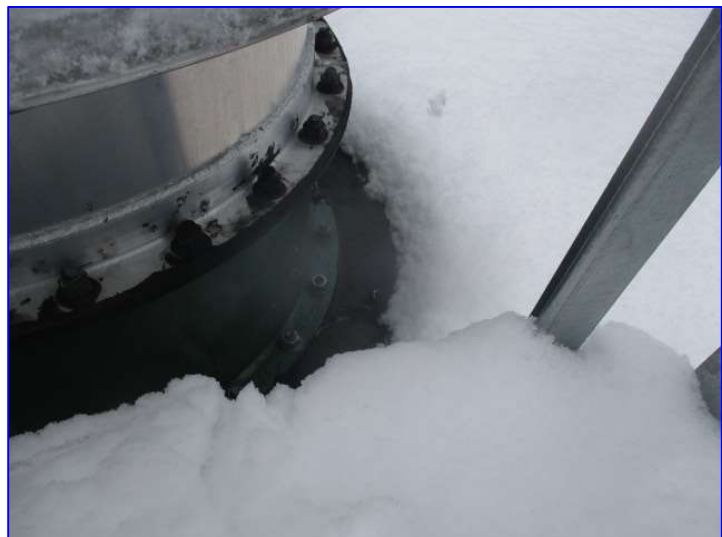
Photo 9 – Exterior (Jan 2020) – View of the roof center vent.

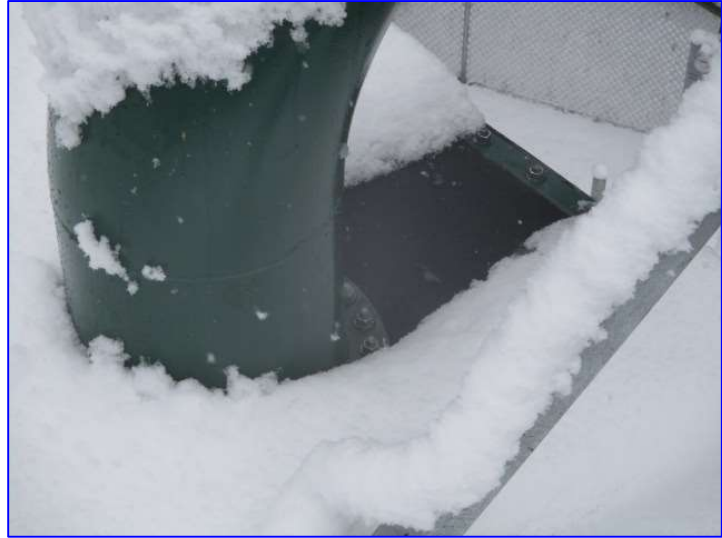
Photo 10 – Exterior (Jan 2020) – View of tank accessories.

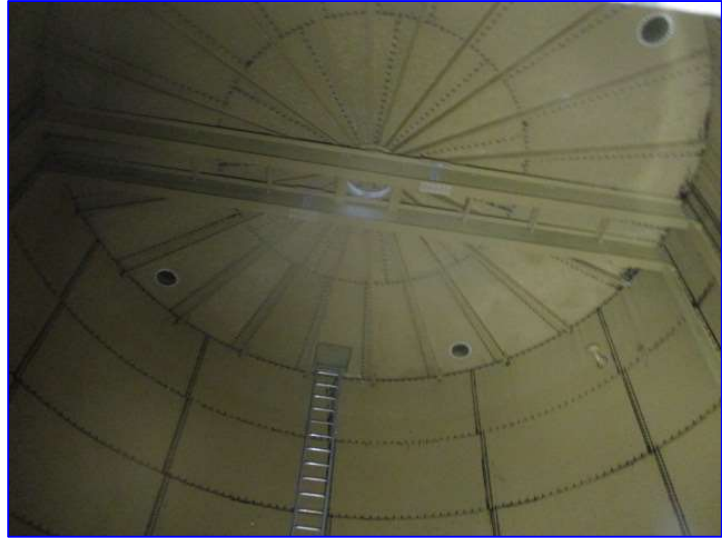
Photo 13 – Interior (Jan 2020) –  
Overview of the bridge supported roof  
structure.

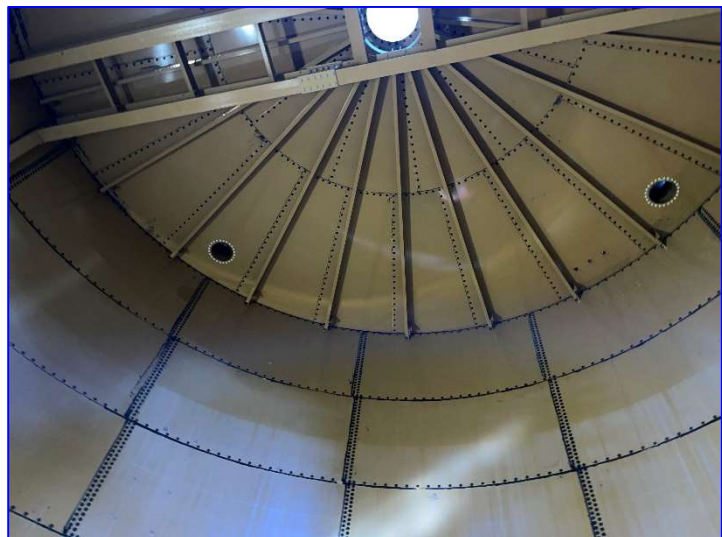
**Photo 21 – Interior (June 2022) – View of the interior bridge supported roof structure.**

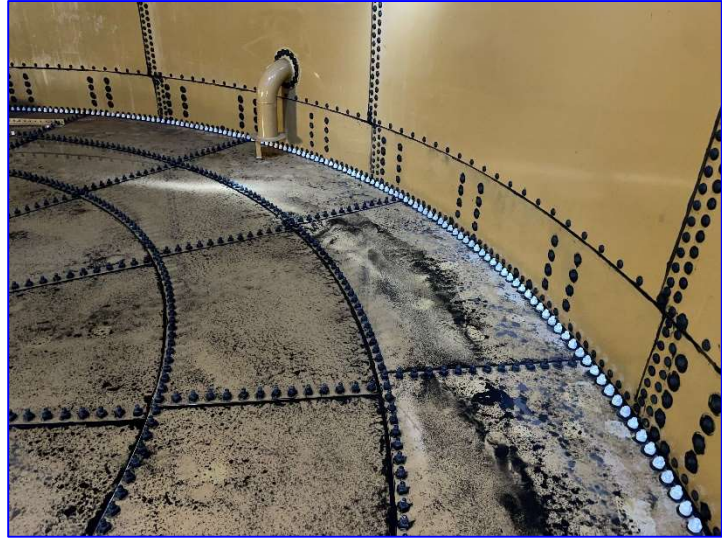
Photo 25 – Interior (June 2022) –  
Overview of the shell and tank bottom.

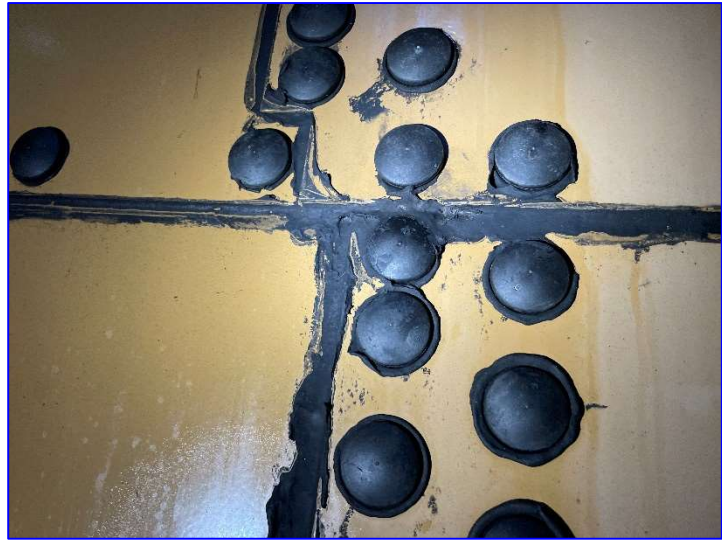
Photo 28 – Interior (June 2022) – View of a plate lap segment of the shell where sealant appears to be performing properly.

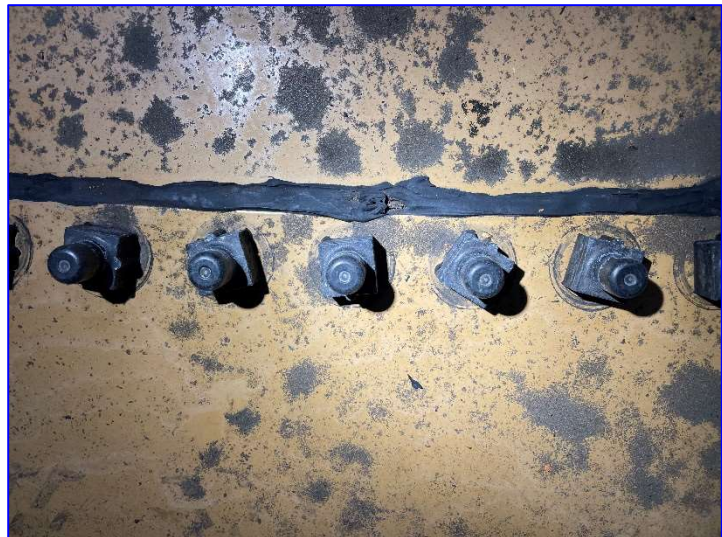
Photo 41 – Interior (June 2022) – View of the sealant used at the tank bottom plate laps.

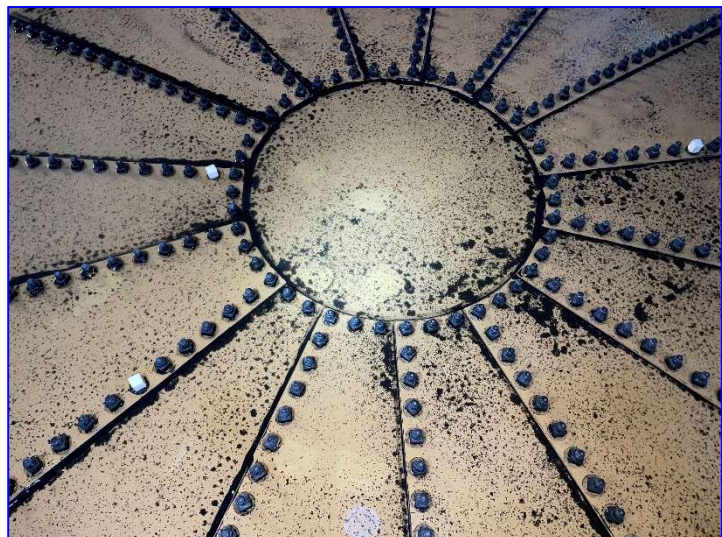
Photo 42– Interior (June 2022) – View of the tank bottom at the center of the tank.
