# Memorandum

## Alleghany Tank Inspection

December 22, 2022

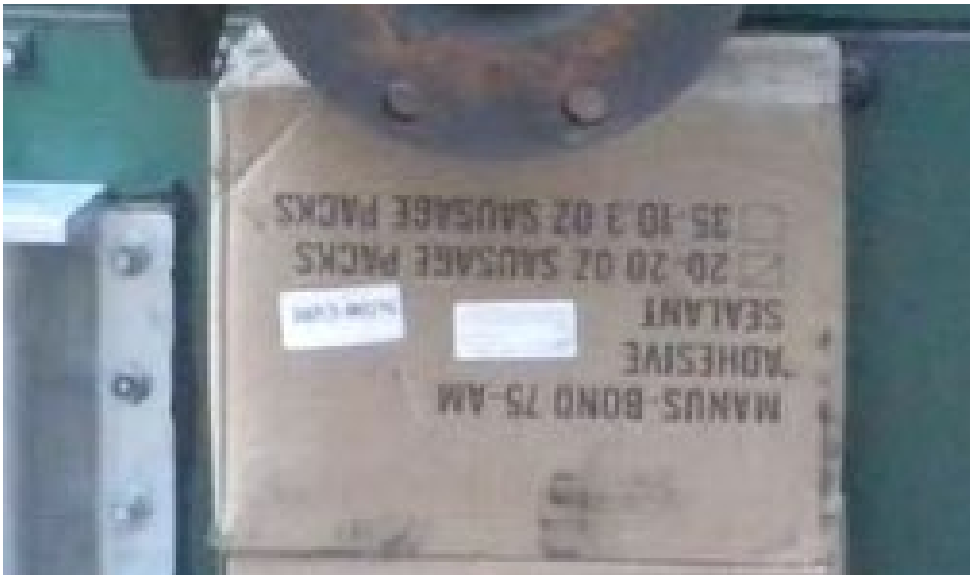
Close up of box.

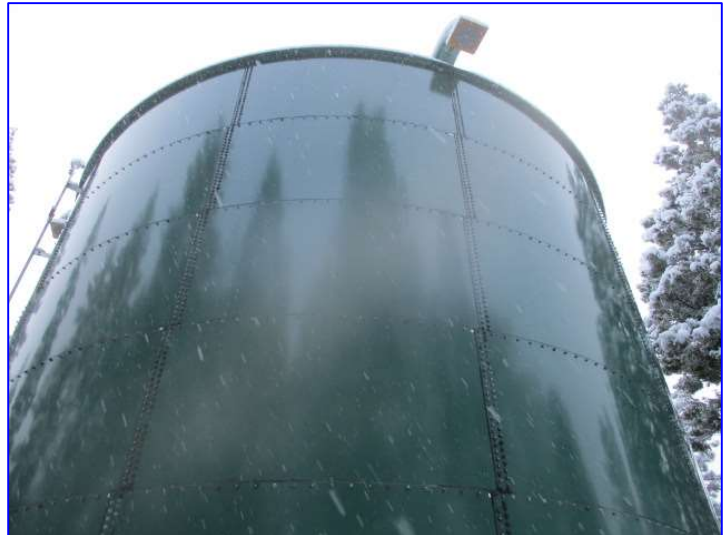
**Photo 2 – Exterior (Jan 2020) – View of  
the six shell courses.**

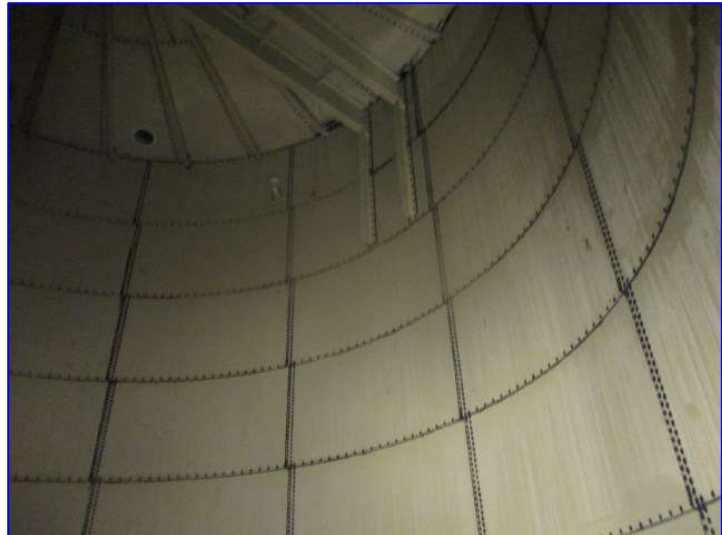
Photo 14 – Interior (Jan 2020) –  
Overview of the interior shell
